City of Portland Office of Management and Finance
Structural Condition Assessment Report of Four Smart Park Garages,
Portland, Oregon

29 May 2008

**Structural Condition
Assessment Report**

**Four Smart Park Garages
Portland, Oregon**

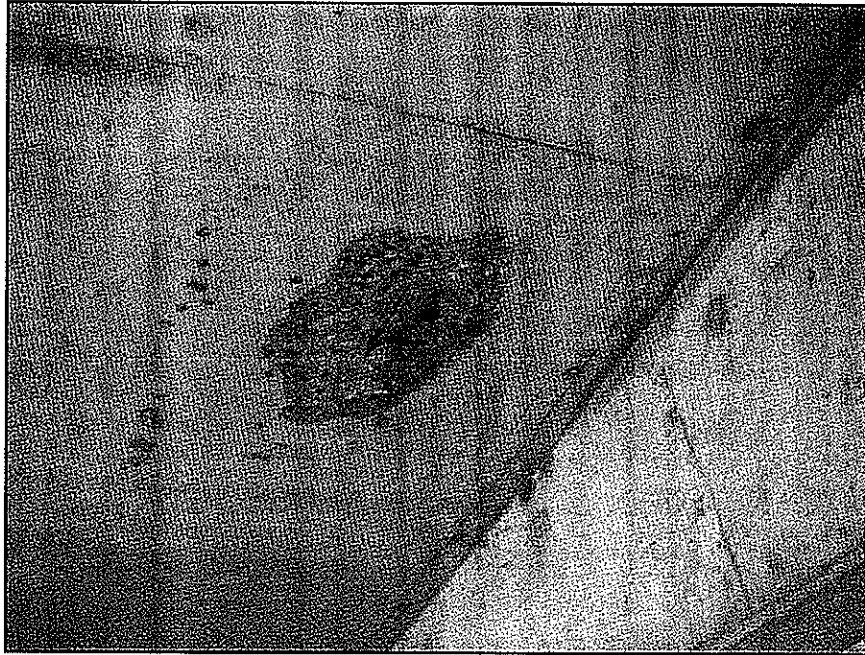
Photo 1 - Concrete deterioration and rebar exposure

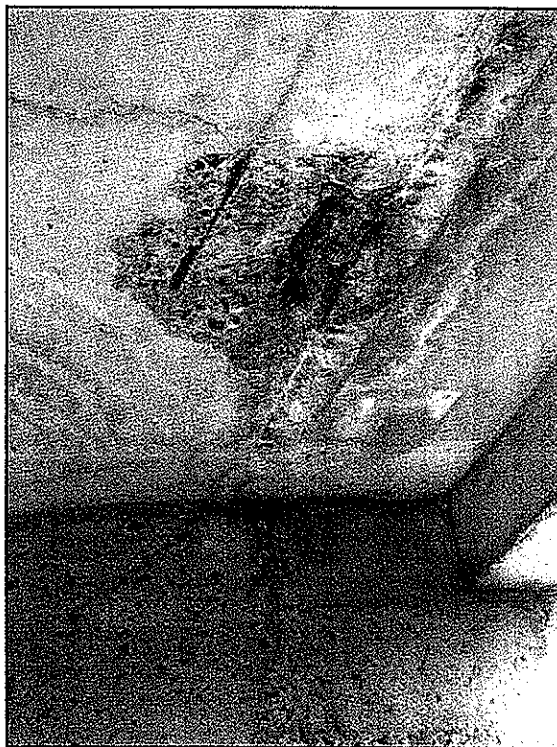
Photo 2 - Concrete deterioration and rebar exposure

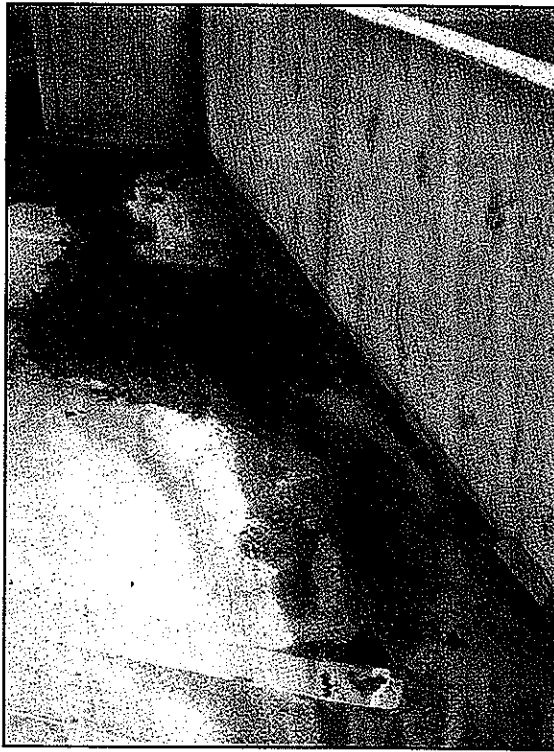
Photo 3 - Concrete delamination and ponding

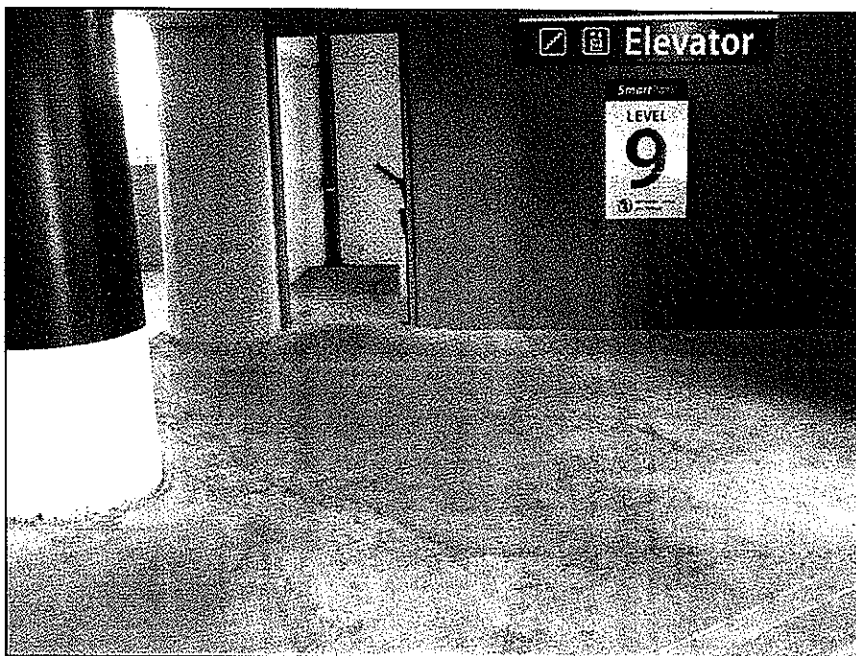
Photo 4 - Concrete slab cracking

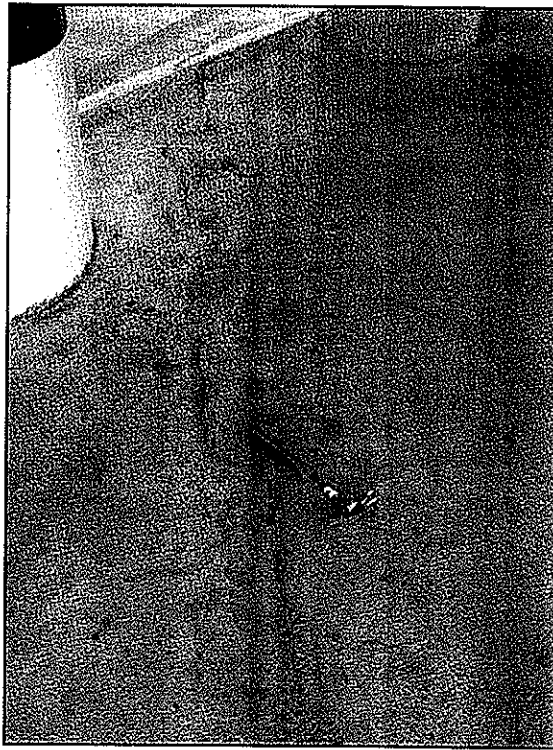
Photo 5 - Concrete slab cracking

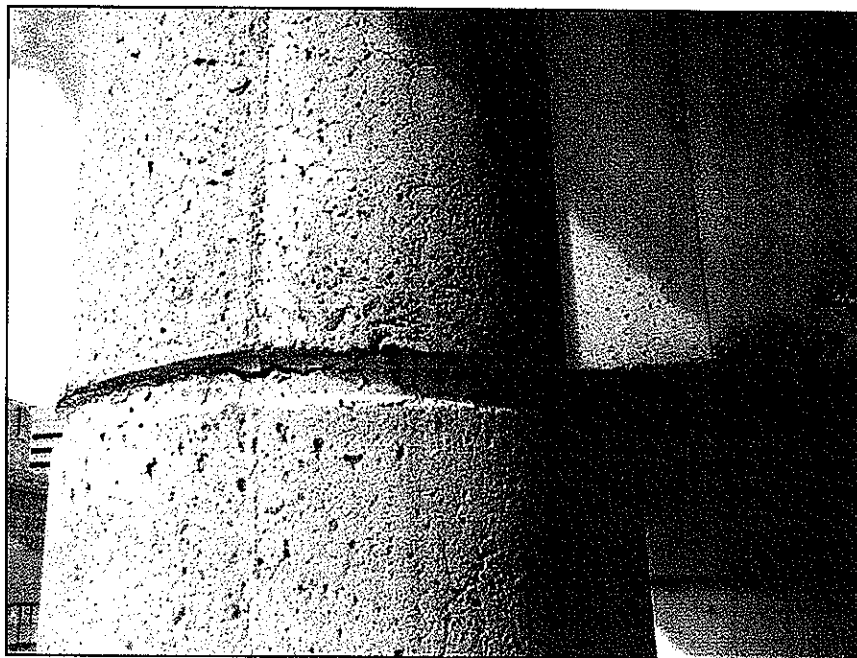
Photo 6 - Concrete column cracking

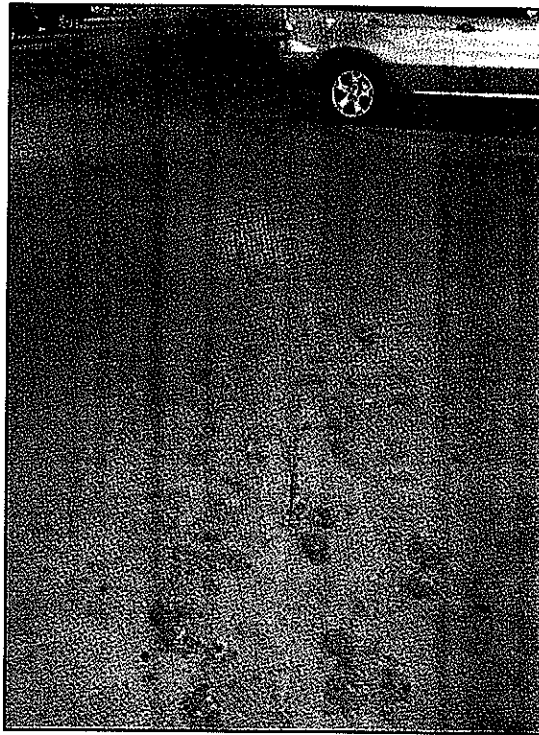
Photo 7 - Poor concrete construction

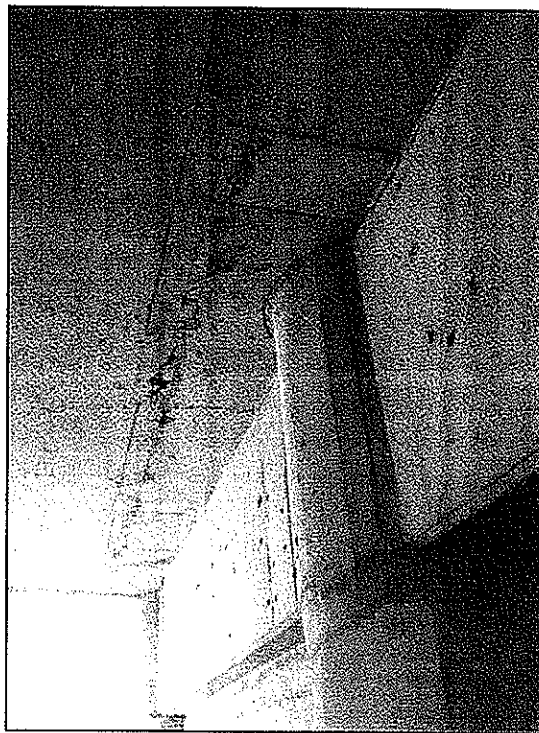
Photo 8 - Concrete cracking and water intrusion

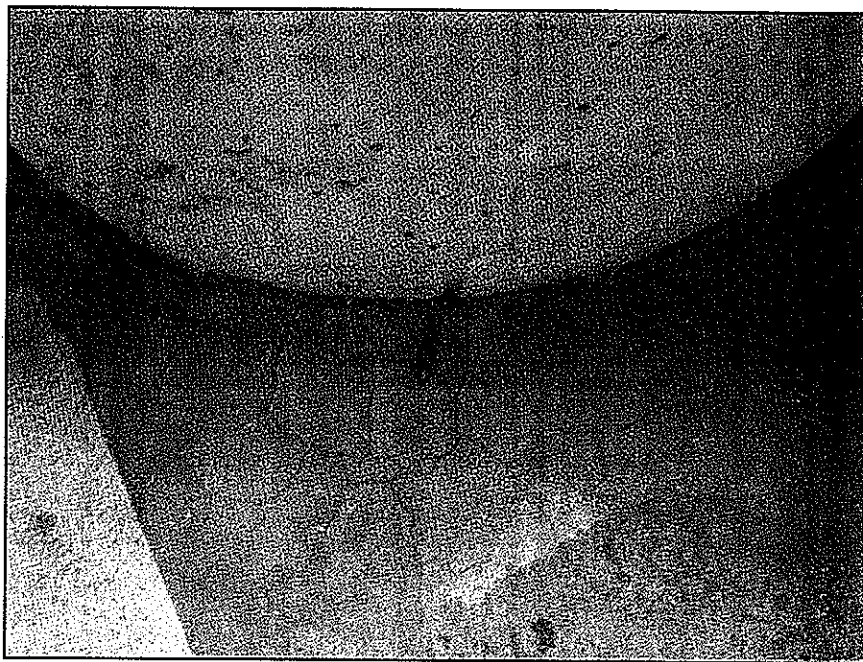
Photo 9 - Delamination of concrete slab

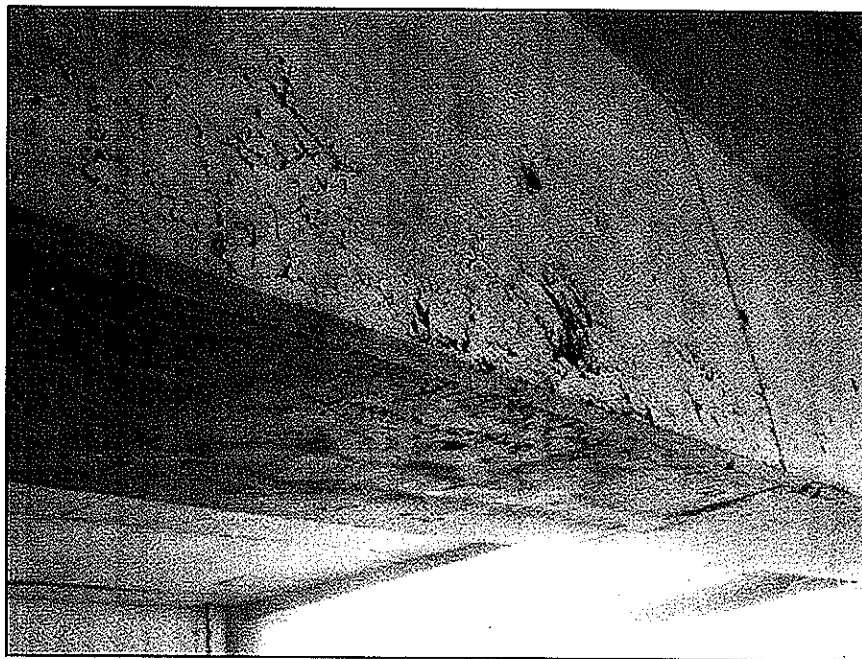
Photo 10 - Past concrete repair and further deterioration

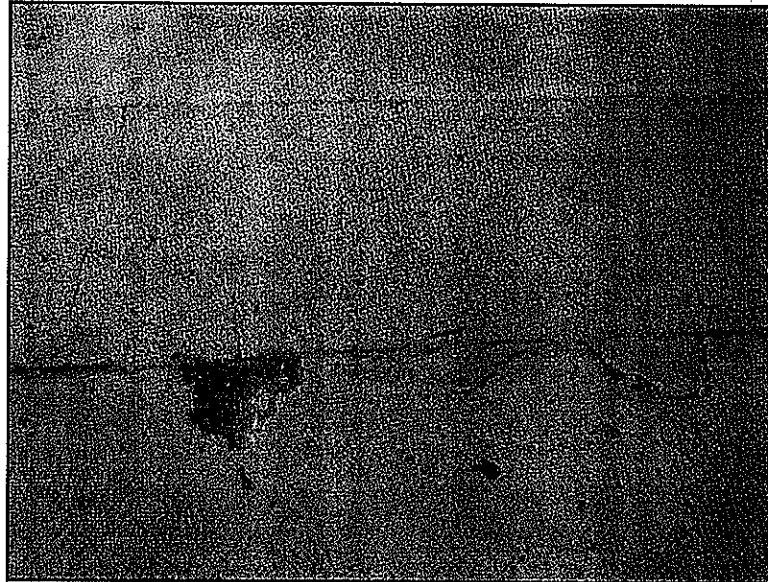
Photo 11 - Concrete spalling at slab closure pour strips

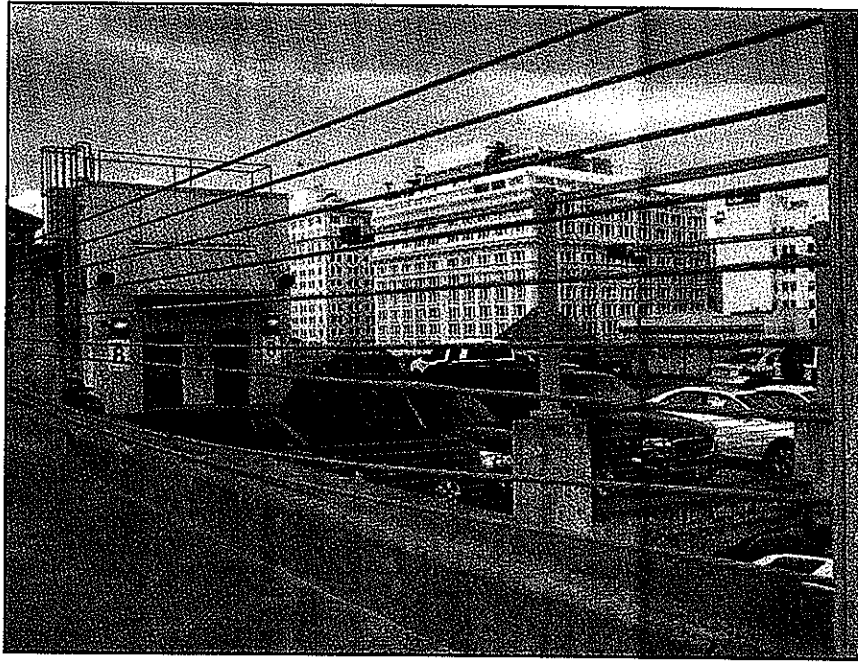
Photo 12 - Loose guard cables

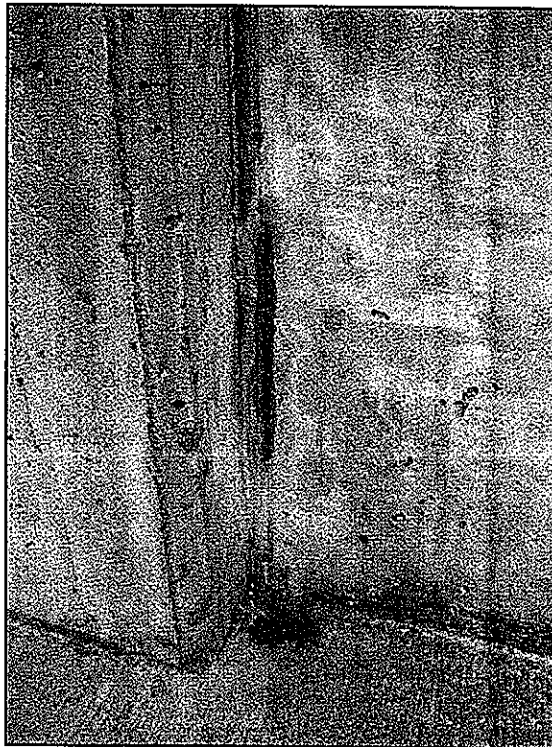
Photo 13 - Rebar exposure

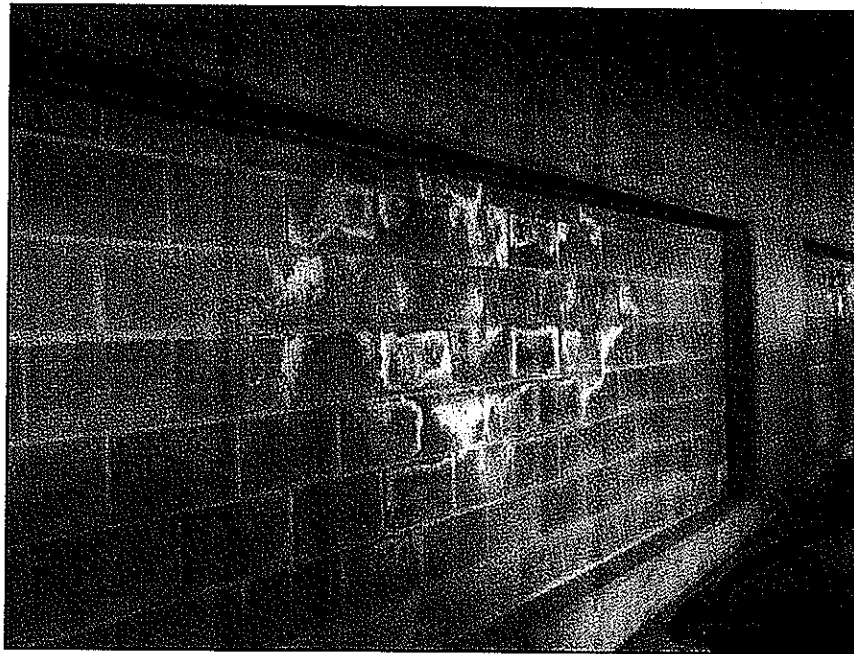
Photo 14 - Efflorescence mineral deposits

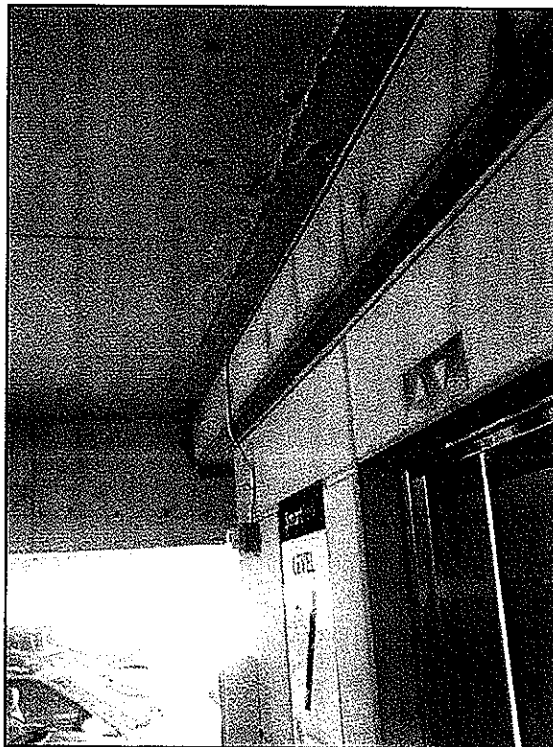
Photo 15 - Mineral buildup and leaking

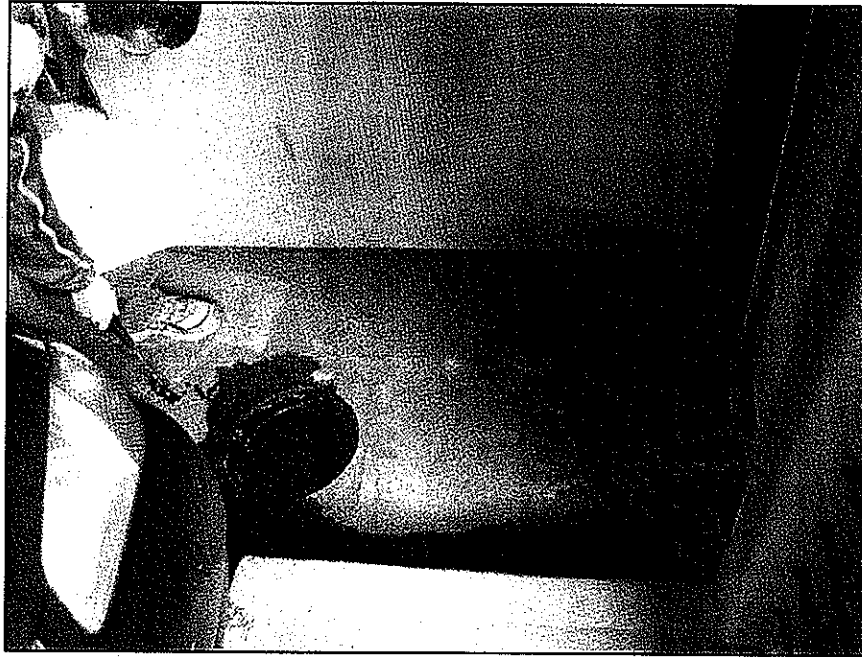
Photo 16 - Clogged storm drain

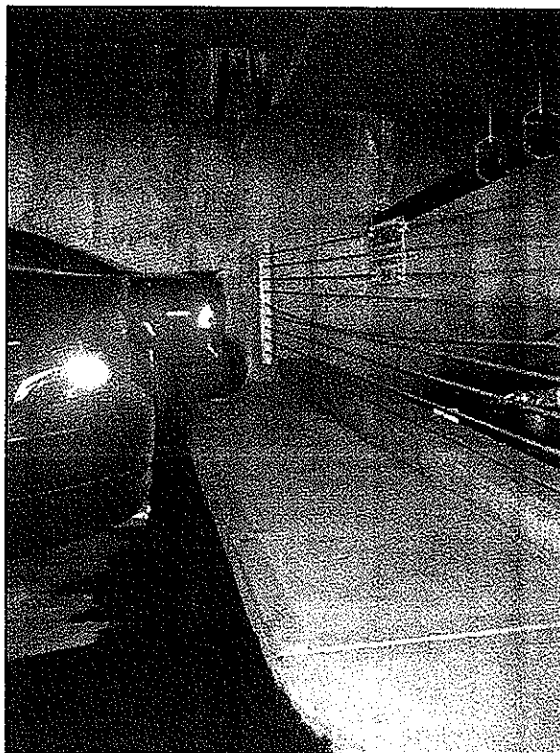
Photo 17 - Water ponding and intrusion; Loose guard cables

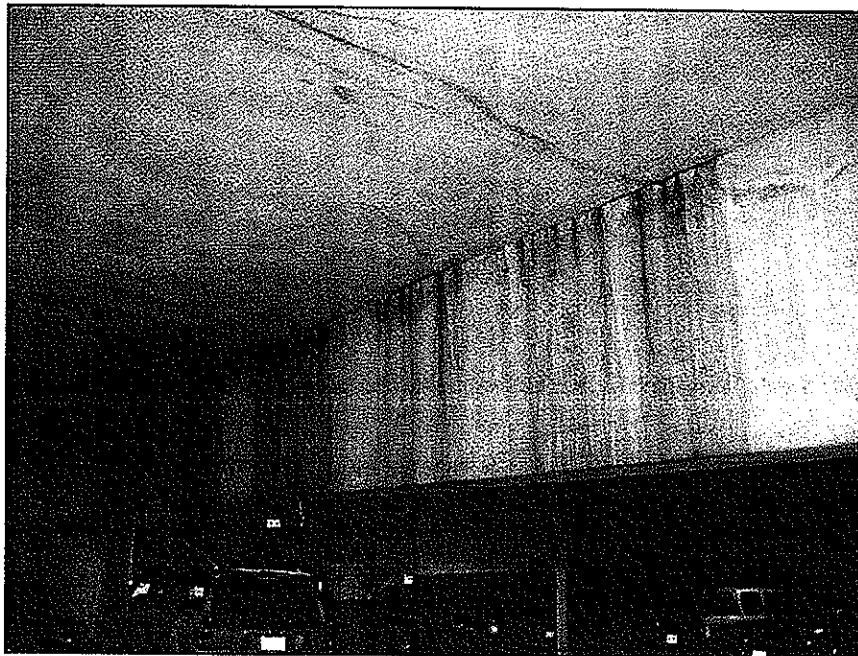
Photo 19 - Water Intrusion

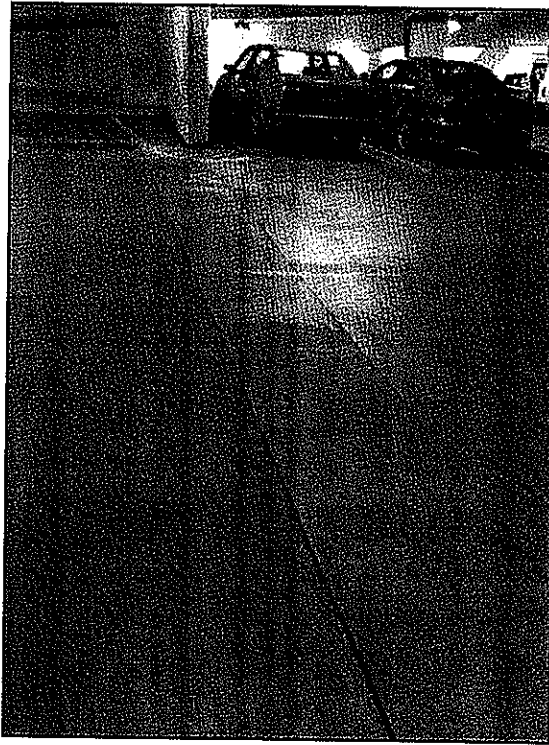
Photo 20 - Concrete slab closure pours

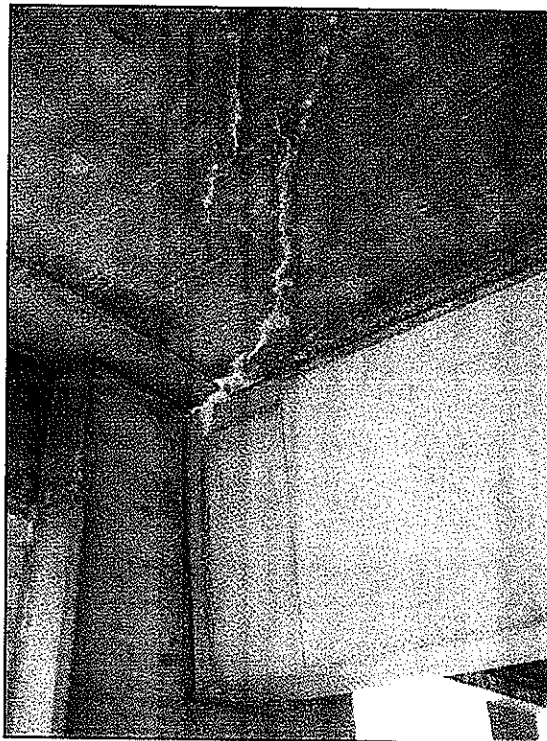
Photo 21 - Water and mineral intrusion

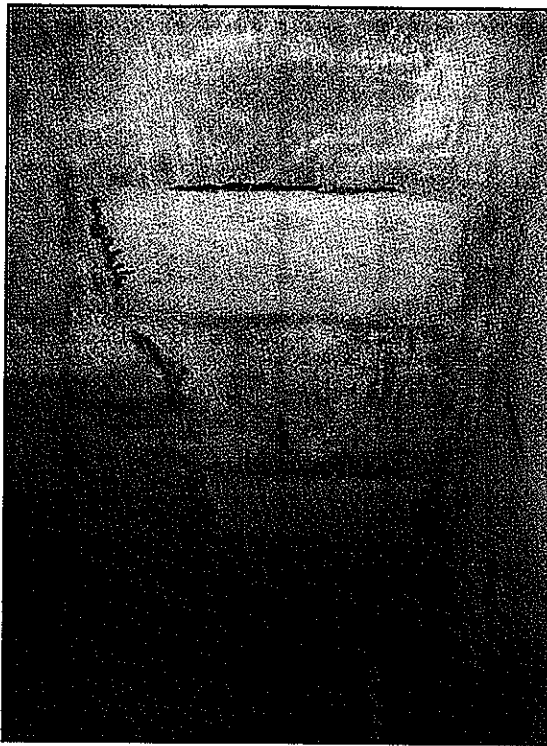
Photo 22 - Water Intrusion at concrete patch

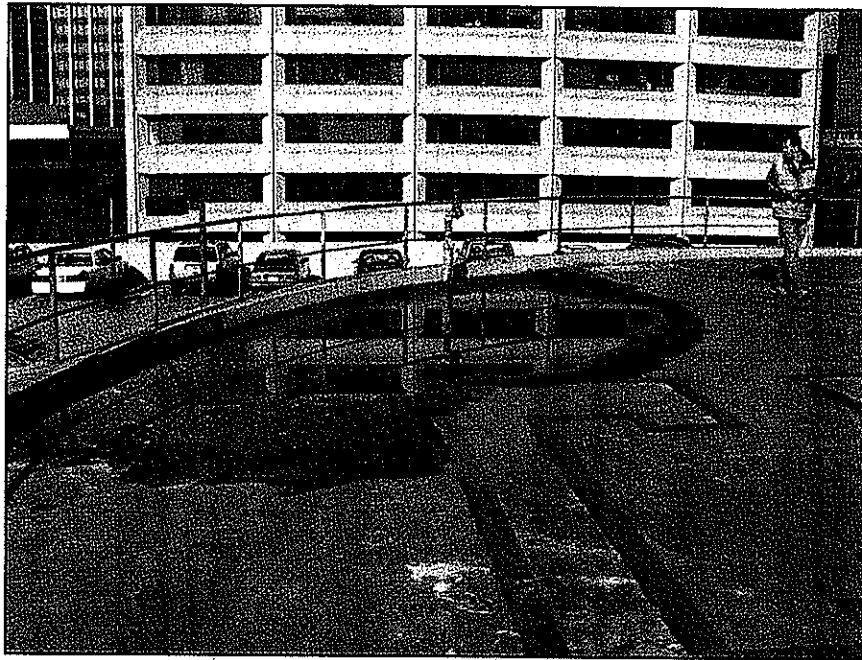
Photo 23 - Isolated water ponding

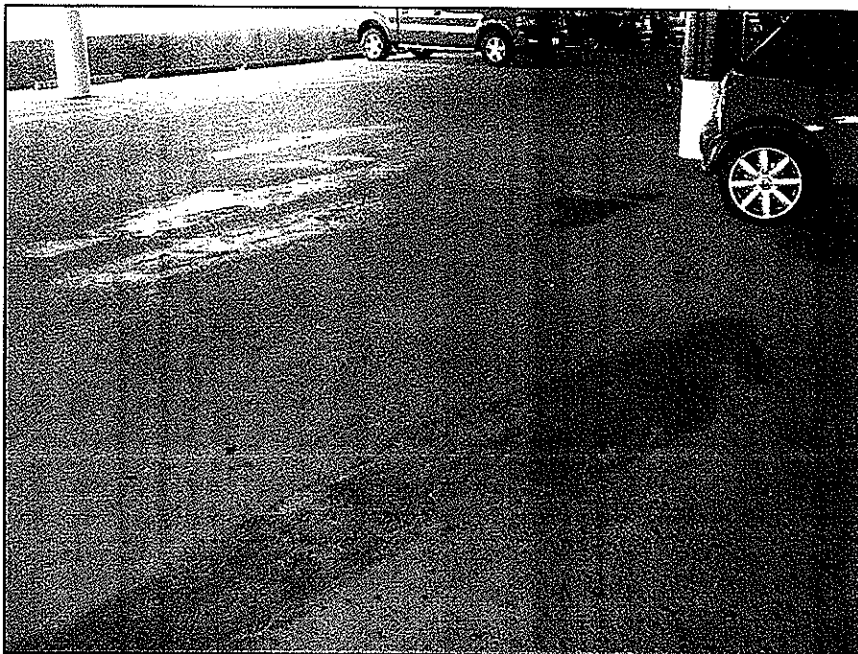
Photo 24 - Cracking and patching of concrete slab

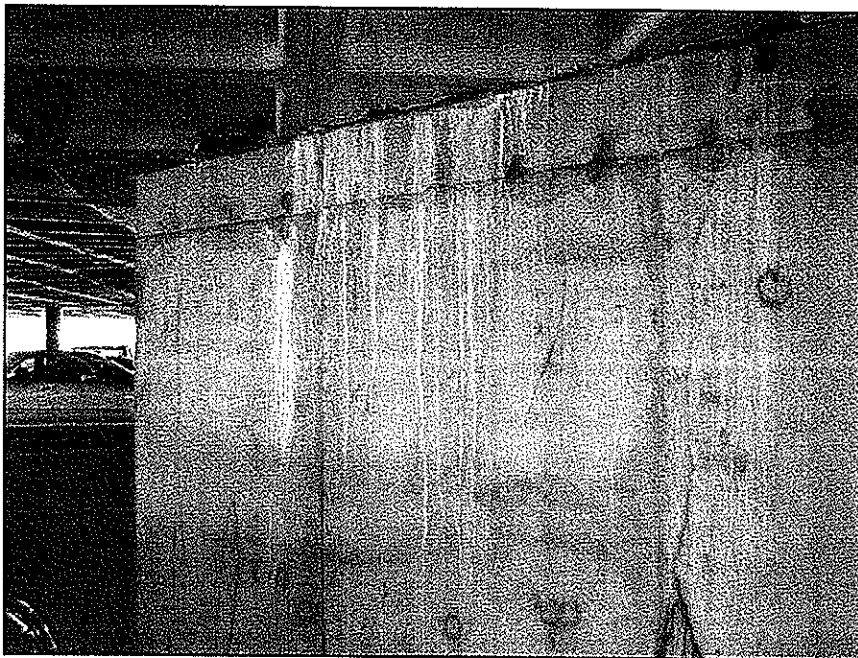
Photo 26 - Water intrusion

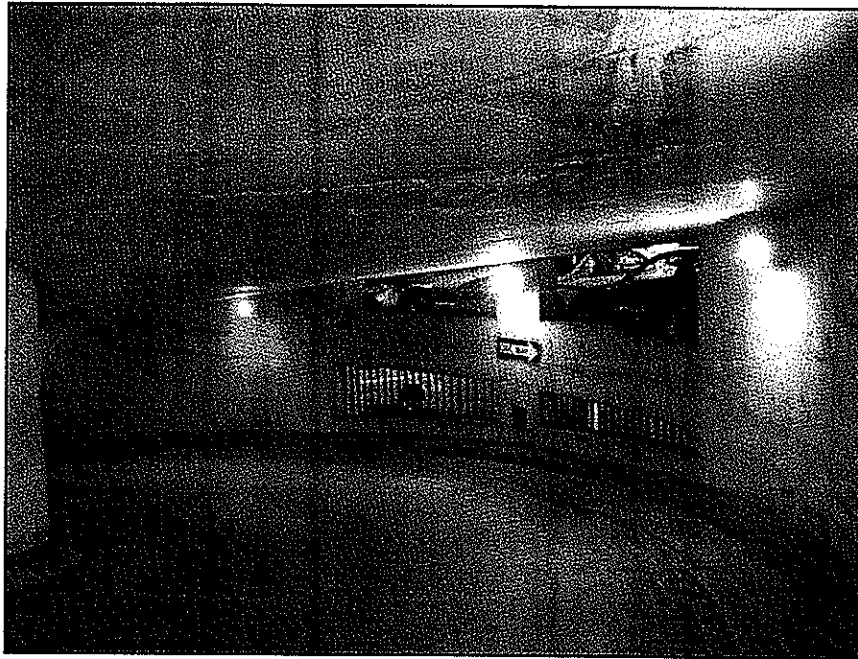
Photo 27 - Water intrusion

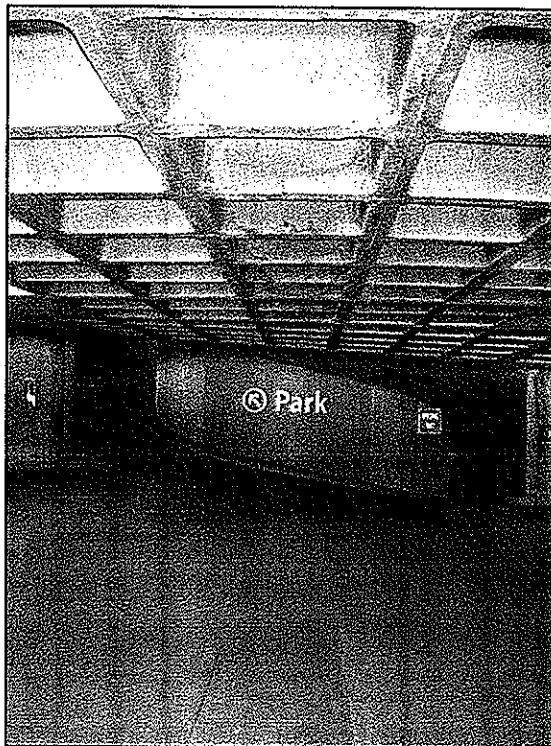
Photo 28 - Concrete slab closure pour

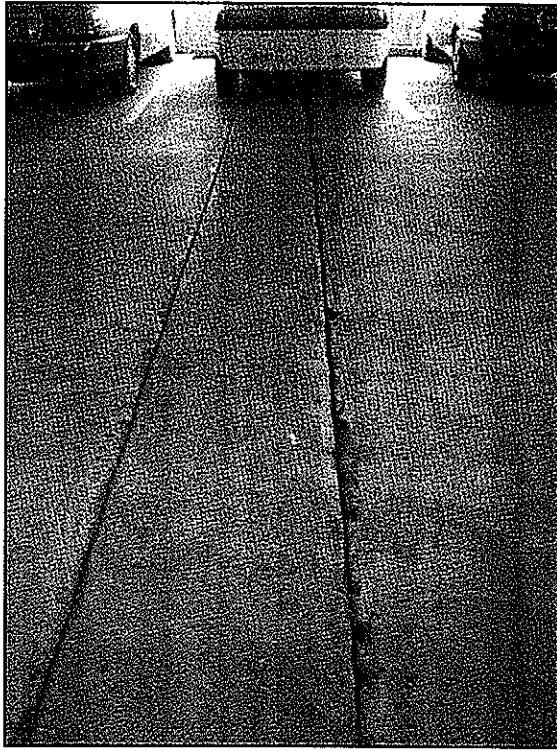
Photo 29 - Concrete slab closure pour with spalling

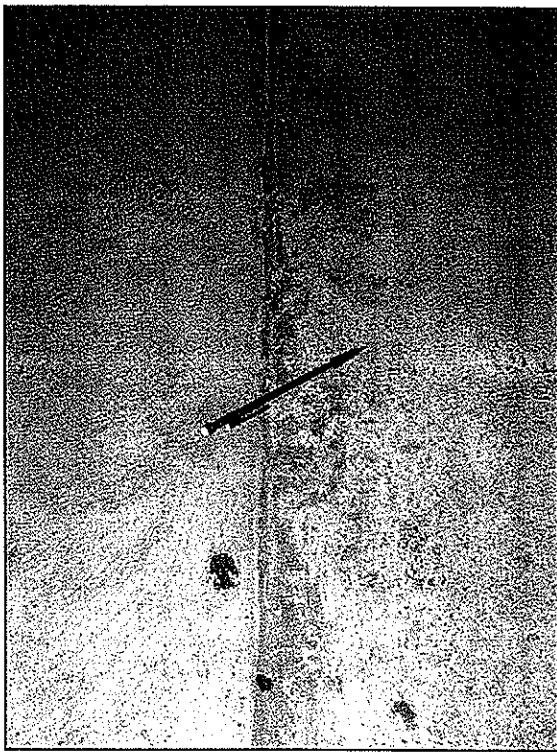
Photo 30 - Concrete spalling

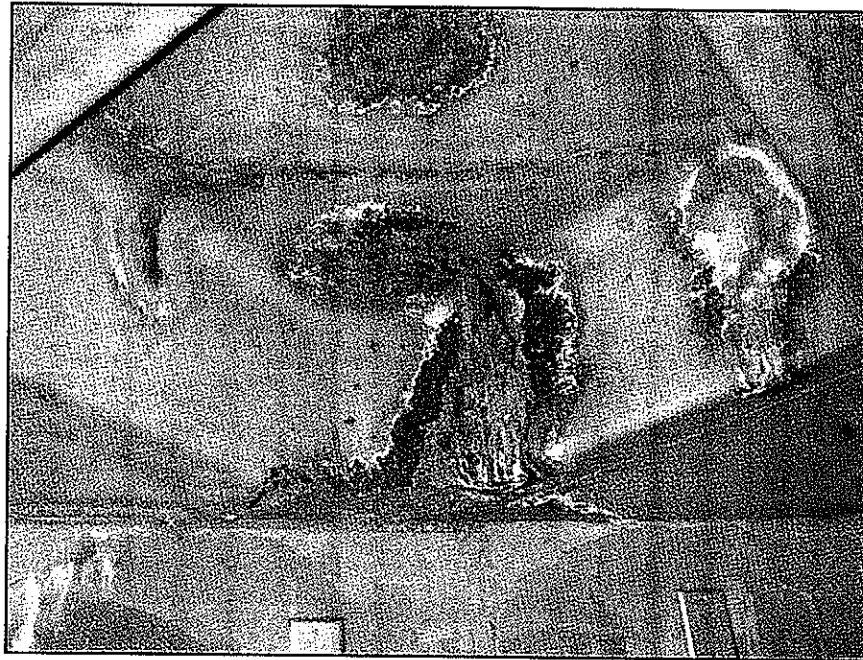
Photo 31 - Concrete cracking with water intrusion

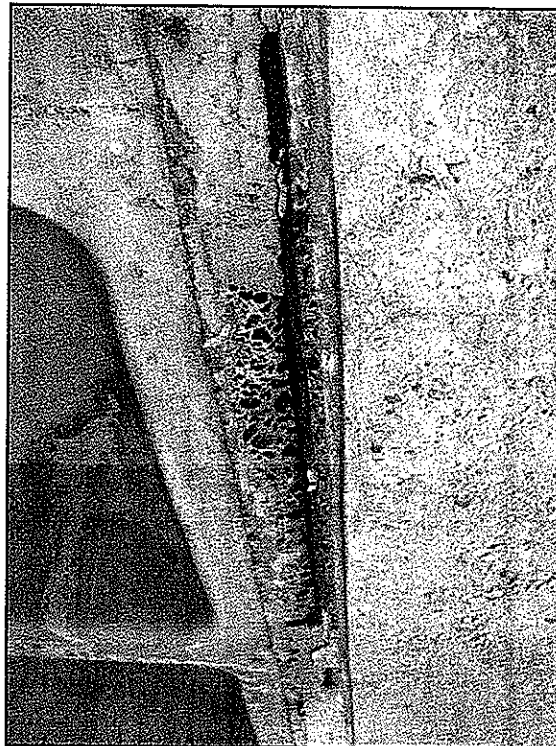
Photo 32 - Rebar exposure

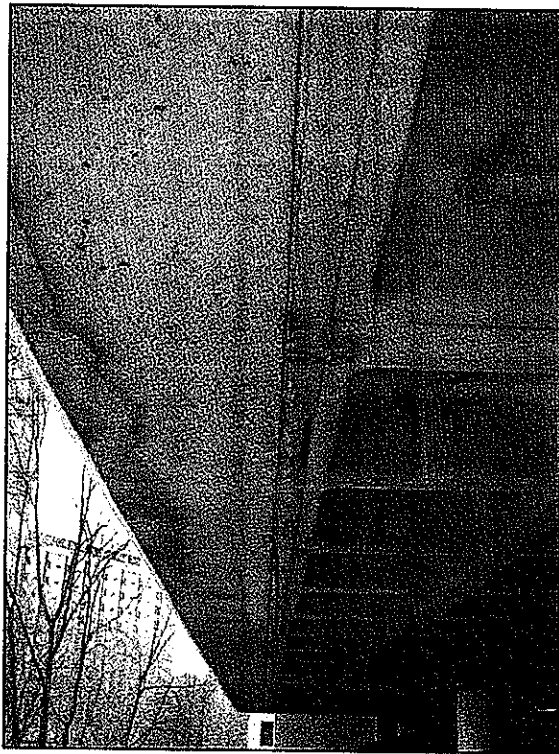
Photo 33 - Rebar exposure

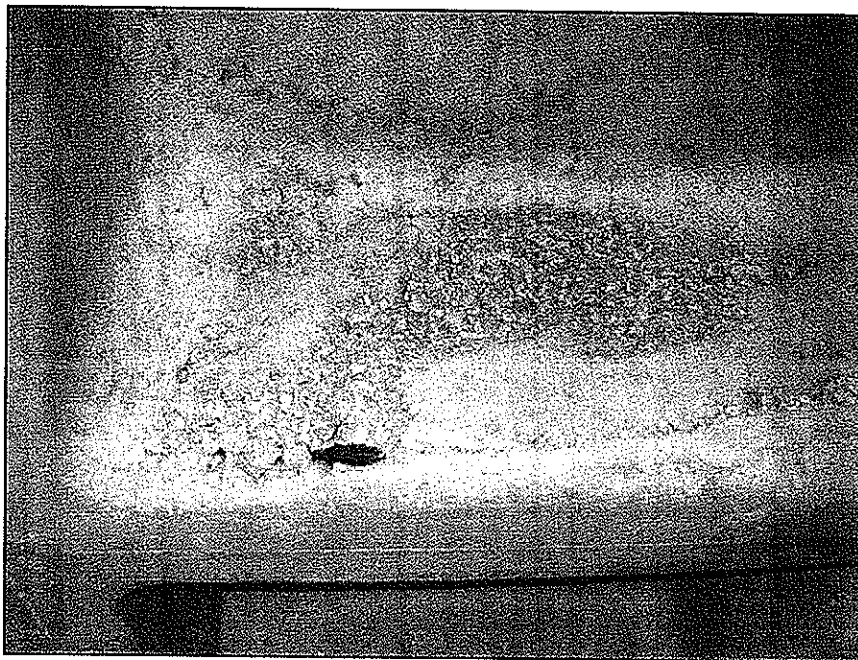
Photo 34 - Concrete deterioration with rebar exposure at "rock pocket"

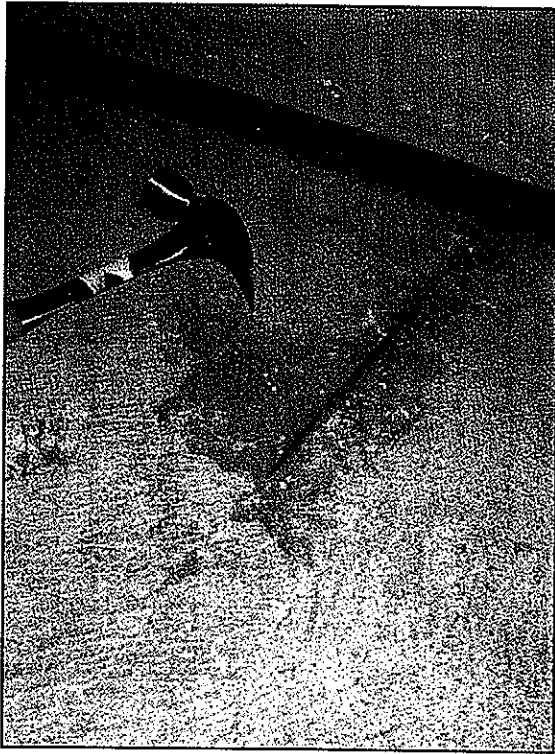
Photo 35 - Concrete delamination with rebar exposure

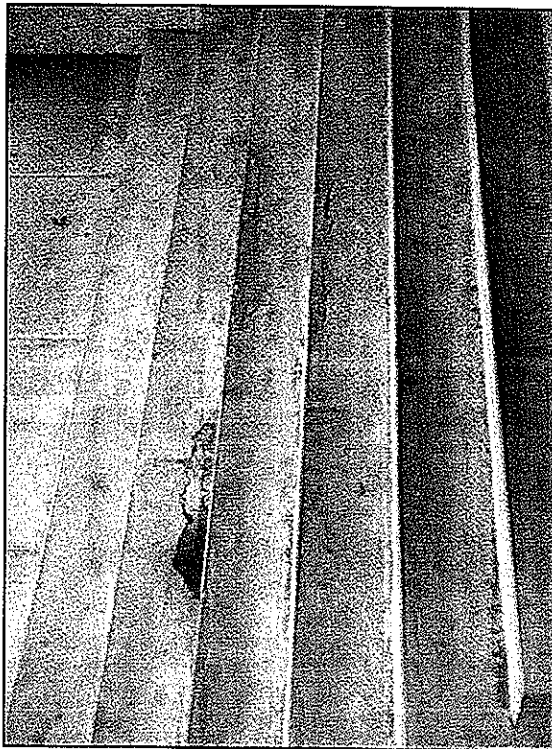
Photo 36 - Concrete stairway cracking

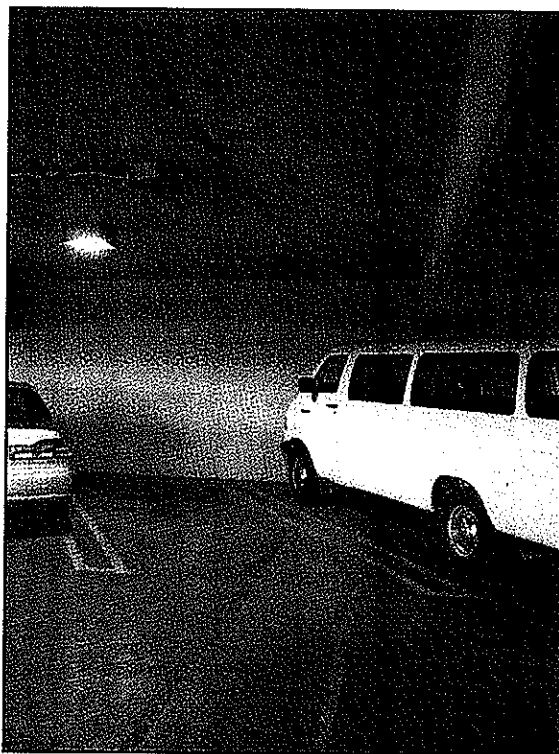
Photo 37 - Concrete slab closure pour and water intrusion

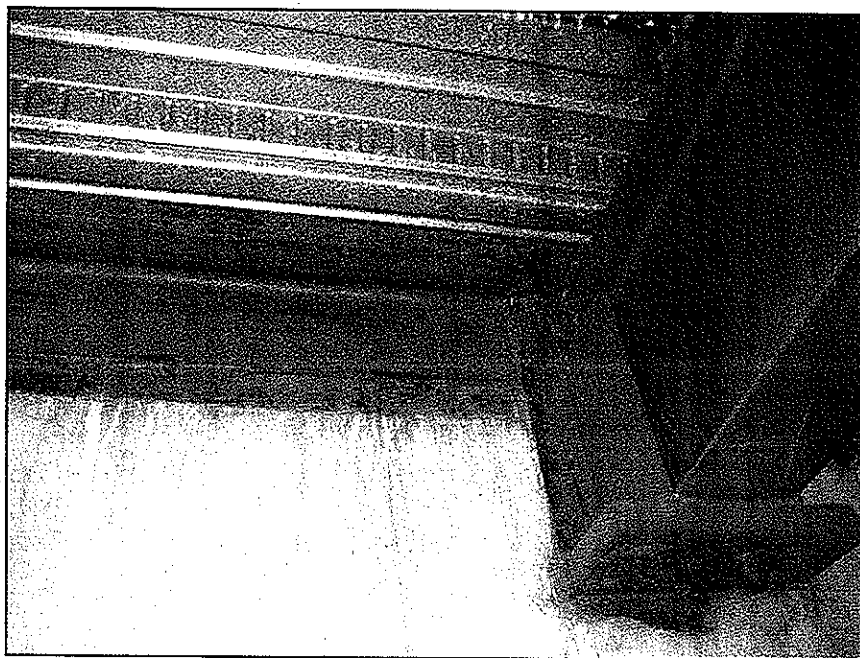
Photo 38 - Steel beam corrosion

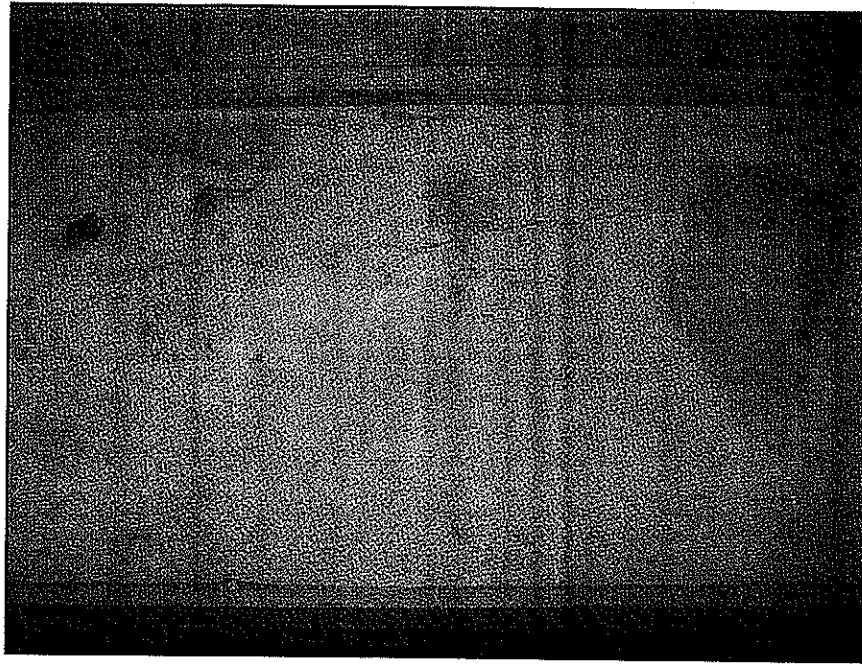
Photo 39 - Concrete beam cracking

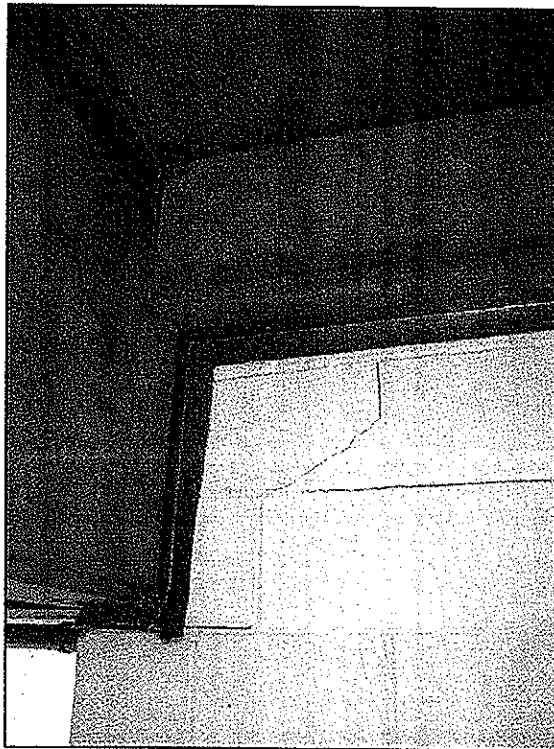
Photo 40 - Masonry cracking

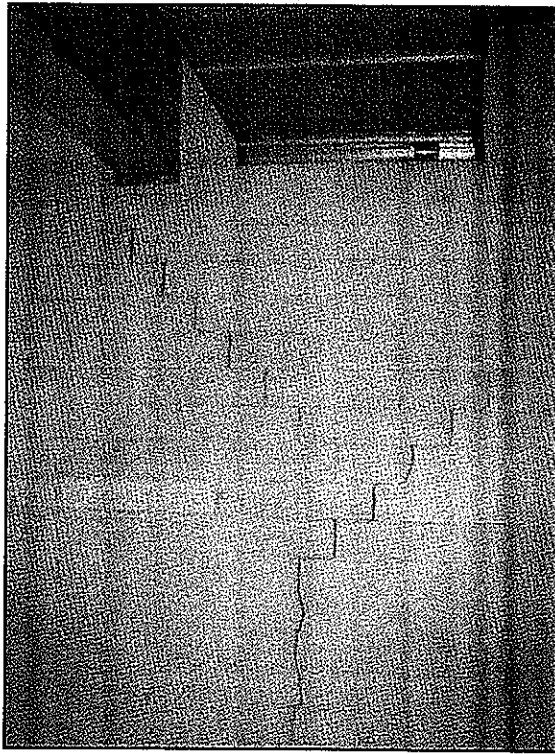
Photo 41 - Masonry cracking

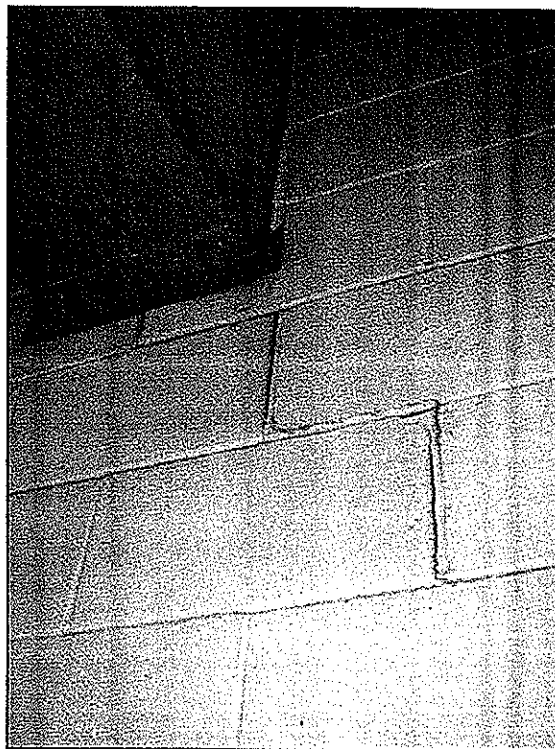
Photo 42 - Masonry cracking

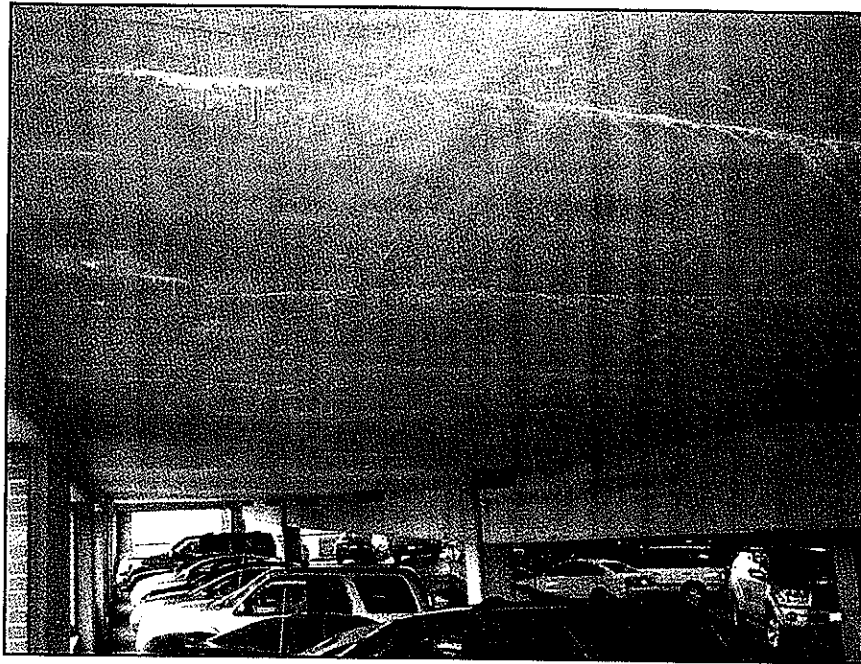
Photo 43 - Concrete cracking

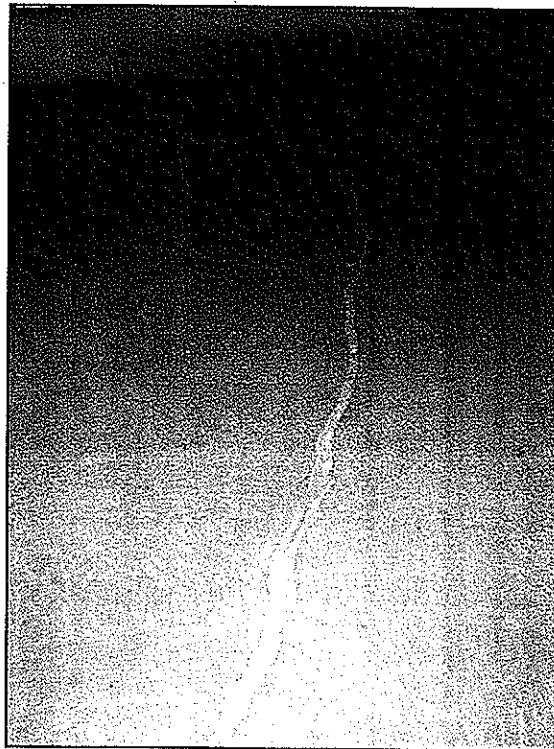
Photo 44 - Concrete joint sealant deterioration

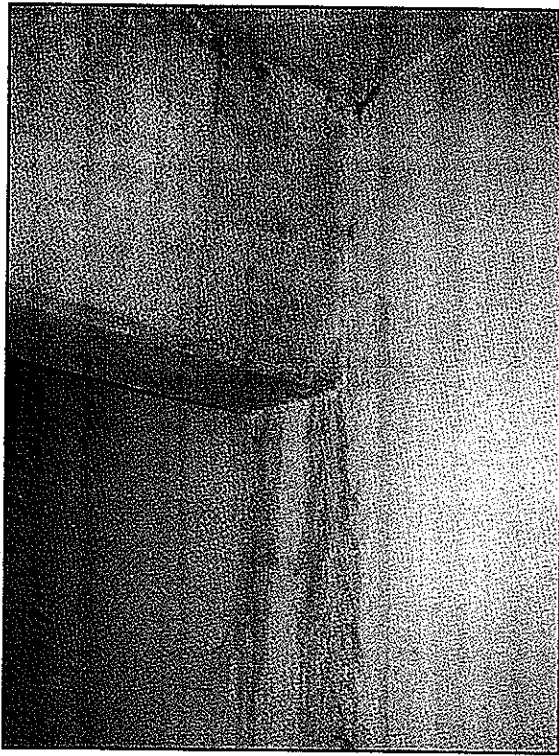
Photo 47 - Water intrusion at beam-wall connection (wall cracking)

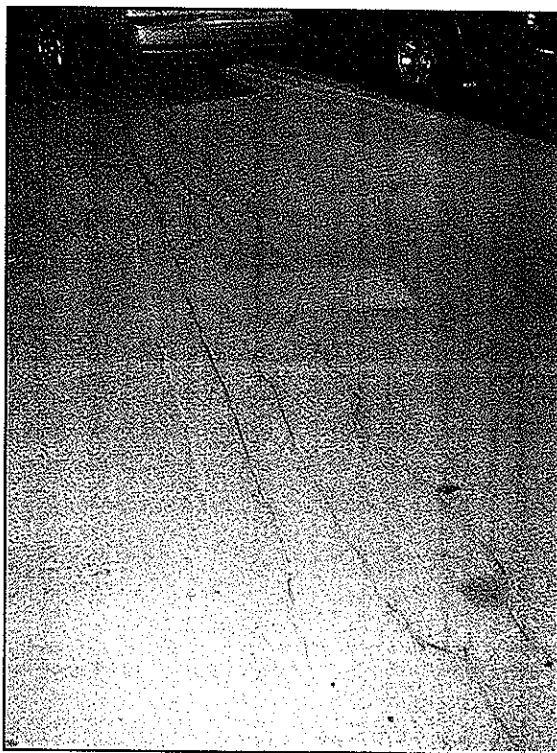
Photo 48 - Negative bending moment cracking of concrete slab

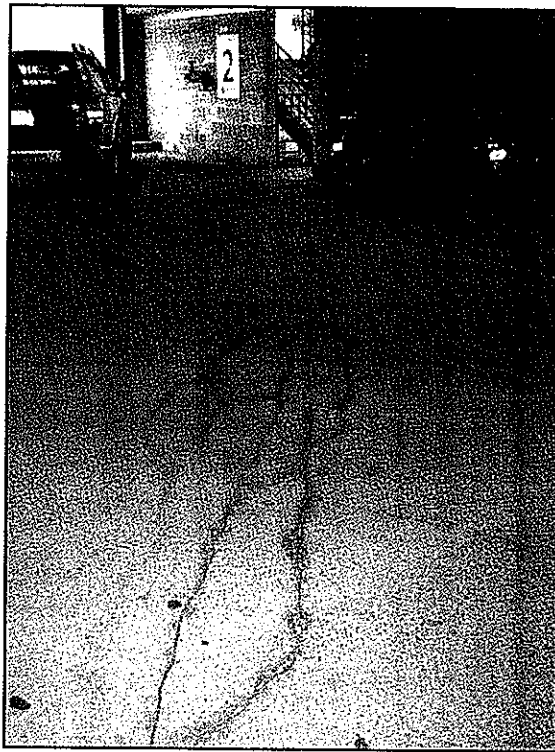
Photo 49 - Concrete slab cracking

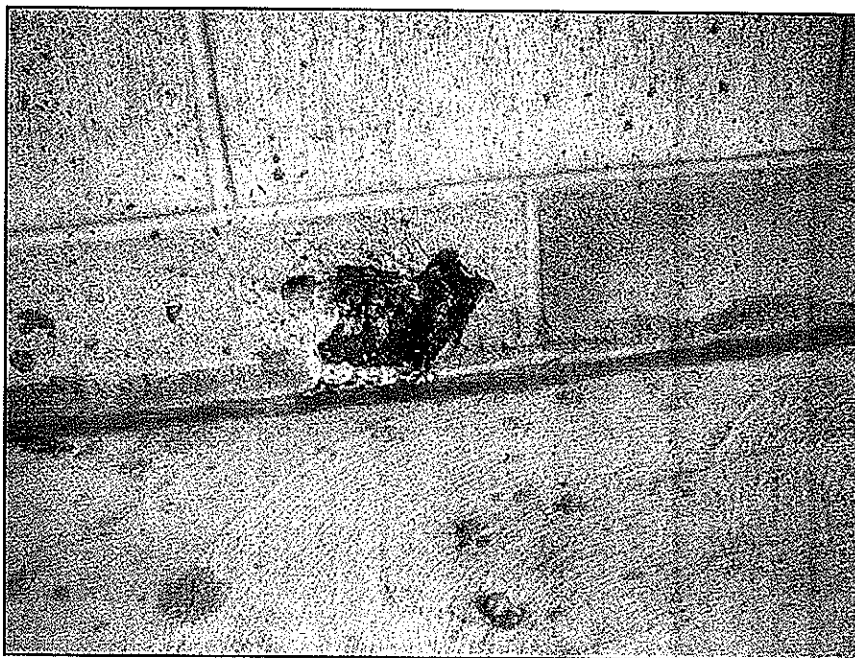
Photo 50 - Rebar exposure

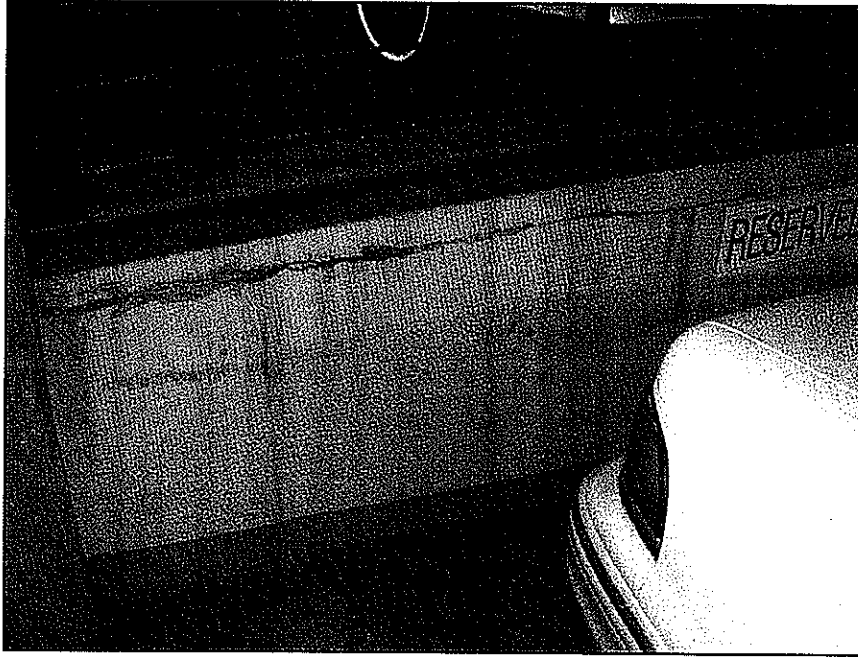
Photo 51 - Concrete top slab cracking
