City of Portland Office of Management and Finance
Structural Condition Assessment Report of Four Smart Park Garages,
Portland, Oregon

29 May 2008

**Structural Condition
Assessment Report**

**Four Smart Park Garages
Portland, Oregon**

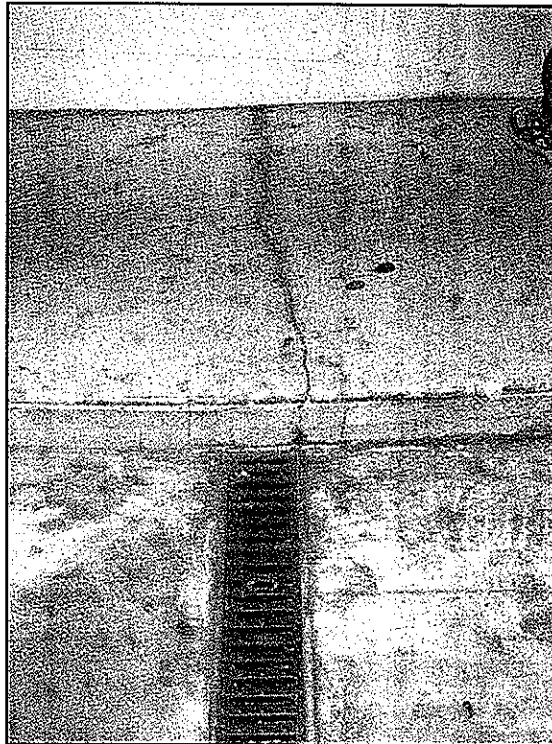
Photo 52 - Concrete sidewalk cracking

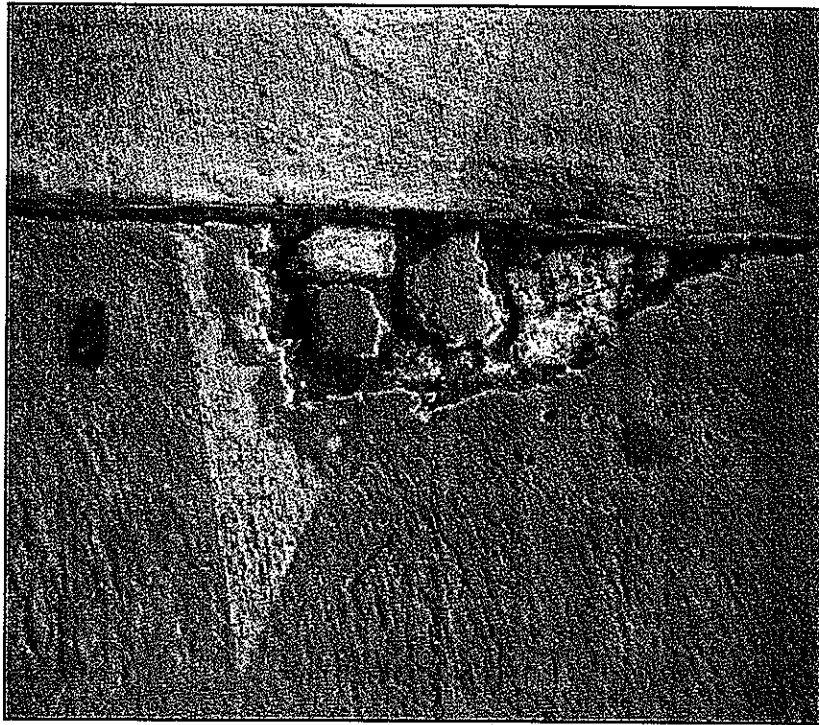
Photo 53 - Concrete spalling

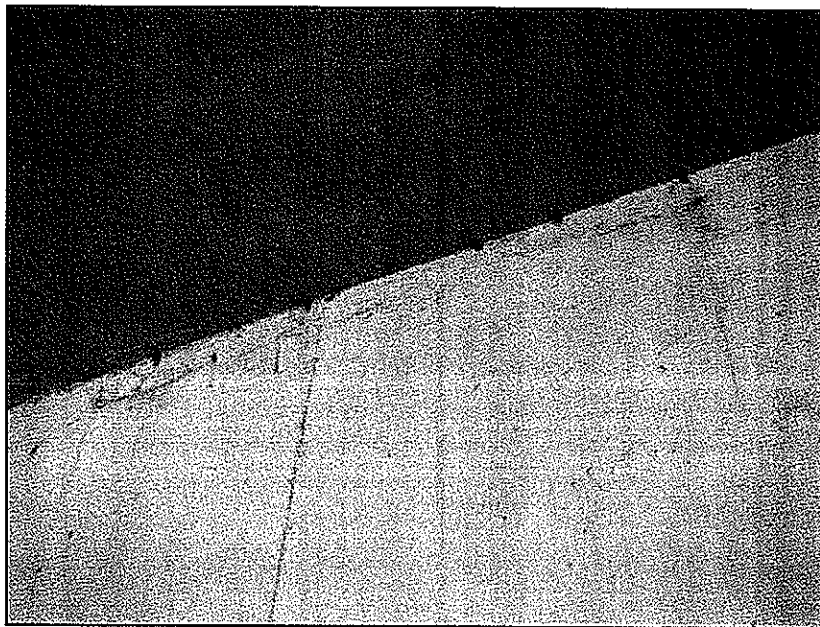
Photo 54 - Rebar exposure

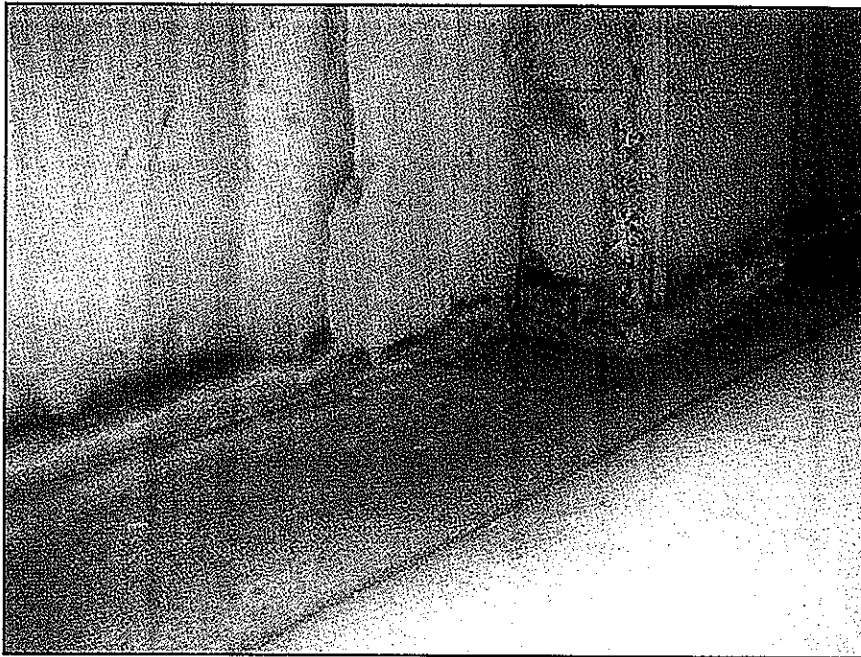
Photo 55 - Concrete deterioration

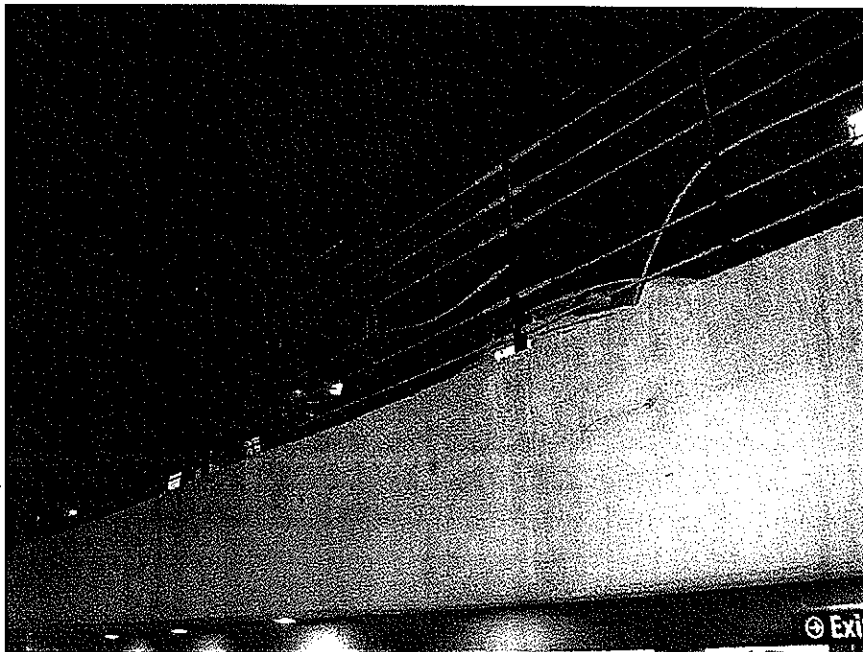
Photo 56 - Loose guard cables

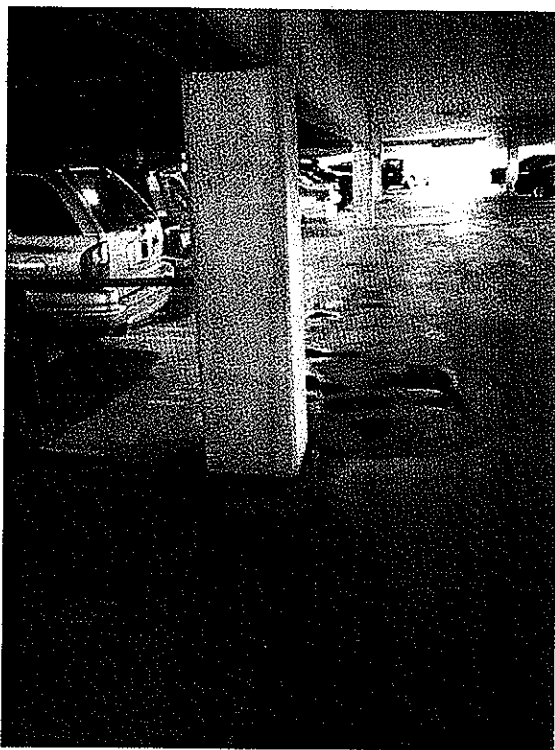
Photo 57 - Isolated ponding

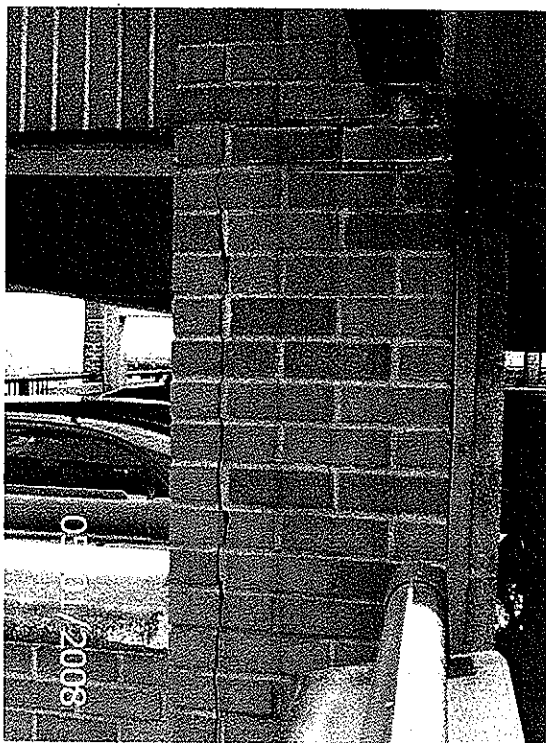
Photo 58 - Cracked brick veneer
